Field Remedy: 2604

Subject: Engine A/Z16/18XER - Booming Noise between 2500 – 3500 rpm

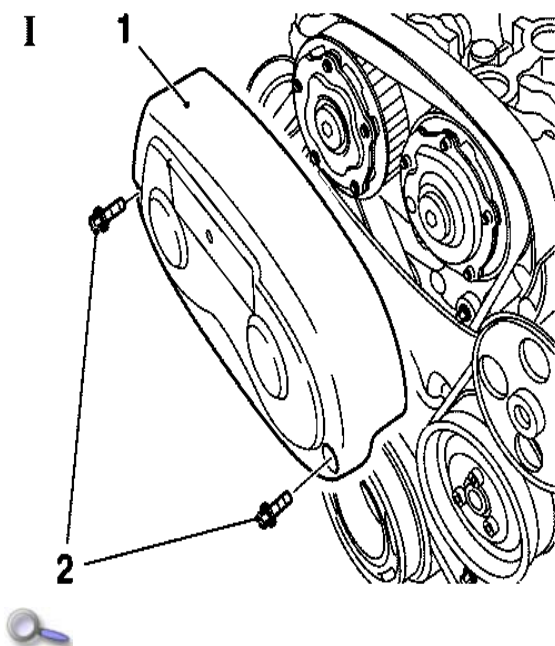
1. Remove upper timing belt cover (Picture I, 1).

- unscrew 2 bolts (2)

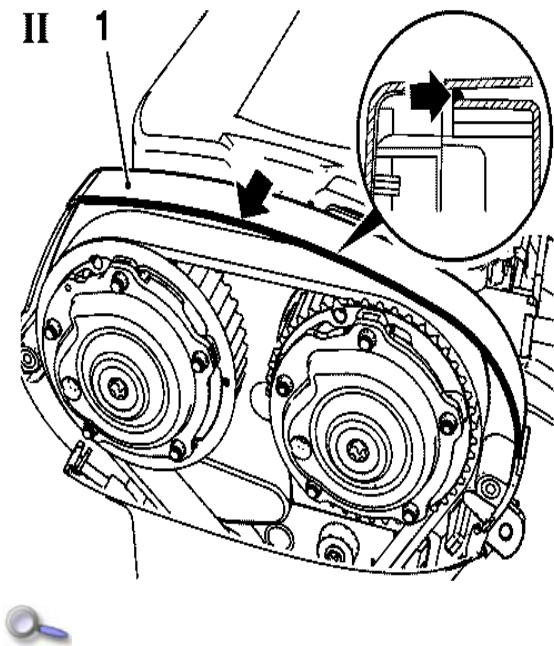
Cause: A burr on the upper portion of rear timing belt cover touching the front cover causes vibrations / booming noise.

3. Remove burr (Picture II, arrows) from rear timing belt cover (1).

Remove burr with a suitable tool.
Protect timing belt drive from contamination.
