# Field Remedy: 2630

**Subject:** Active headrest - Triggered

Astra-J 2010...,Insignia 2009...	All,All	
----------------------------------	---------	--

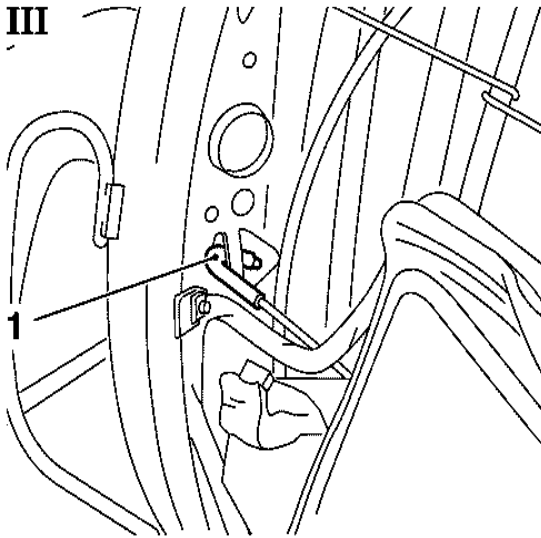
**III**

Wire pad of backrest is unhooked and presses against the release mechanism of the active headrest.

4. Bend left and right side of crossing wires from the backrest structure (Picture III, 1)
- Hook in crossing wire to seat frame
  - Bend 4x hooks of the crossing wires to 180°

Important: Do not damage the protective covers of the wires.
