Field Remedy: 2656

Subject: Inner Sill Trim, Clutch pedal - Distance too low

Astra-J 2010...	All	MT (Manual Transmission)
-----------------	-----	--------------------------

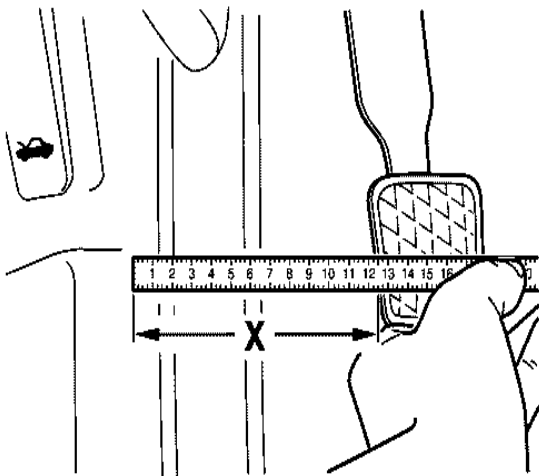
I

1. Measure the distance between clutch pedal and inner sill trim (Picture I, X)

X less than 125 mm is NOK
