Field Remedy: 2676

Subject: Instrument Panel Fuse Box - IEC Bus Bar Incorrect Numbering

Astra-J 2010, Insignia 2010

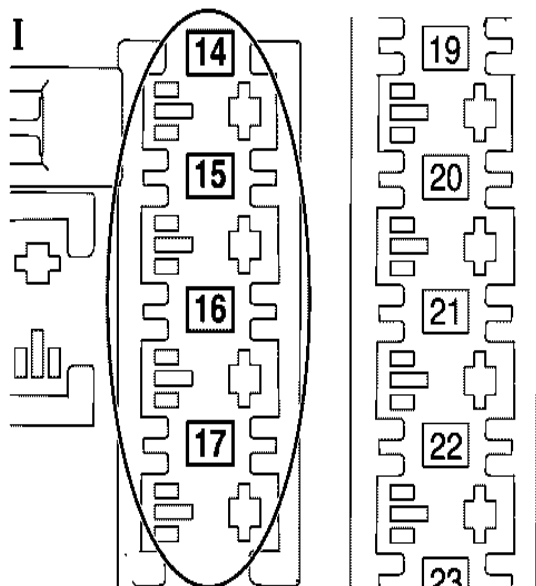
Correct numbering of the IEC Bus bar (Picture I)

14 = Diagnostic connector
15 = Airbag
16 = Central Locking System
17 = HVAC

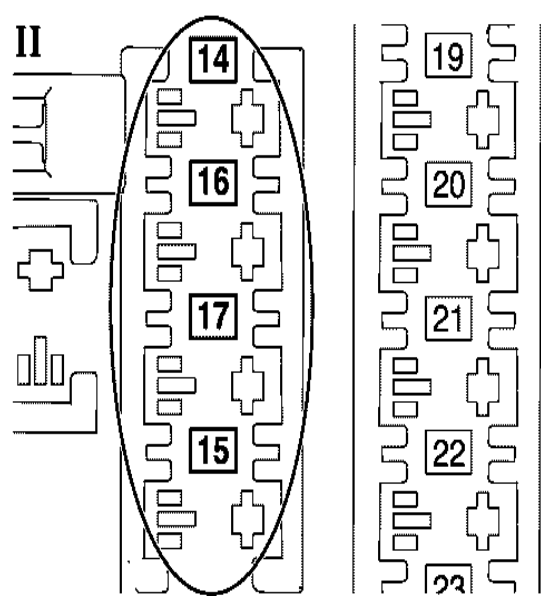
Process deviation during production at supplier.

Incorrect numbering of the IEC Bus bar (Picture II)

Note: Only the numbering on the IEC Bus bar is wrong!
The electrical connector configuration is OK.

14 = Diagnostic connector
16 = Airbag
17 = Central Locking System
15 = HVAC
