Technical Service Bulletin

2718

ABS/ESP Telltale Illuminates - Several Trouble Codes are set

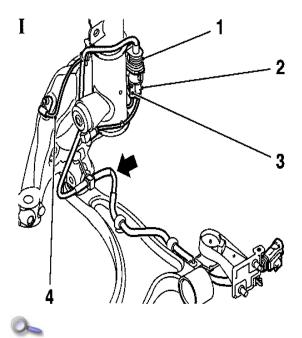
1. Check continuously variable real time damping wiring harness for broken cable (Picture I, arrow)

No external cracks will be visible.

- Measure wiring harness resistance while moving the harness back and forward in shown area (Picture I, arrow)

If a cable is broken inside the continuously variable real time damping wiring harnesses replace the wiring harness by the ${\tt NEW}$ improved version on both sides.

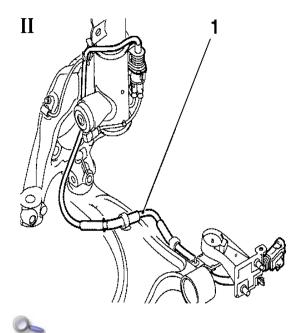
2. Replace continuously variable real time damping wiring harness (Picture II, 1)

If the replacement of the continuously variable real time damping wiring harness is required, pay attention to the NEW routing, as shown in picture II!
