Field Remedy: 2700

Clutch Pedal - Noisy

Astra-J 2010

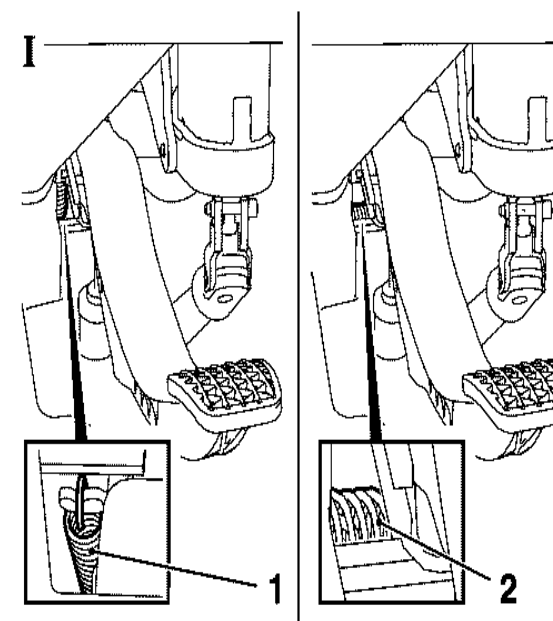
2 different designs of clutch pedal springs exist:

Version I: Clutch return spring (Pic I, 1)

Version II: Over Center Spring (Pic I, 2)

In case of customer complaint, grease clutch pedal spring.

Tip: To get access to the clutch pedal springs for the greasing operation we recommend to use an approximately 1cm wide and 30cm long paint-brush. Alternatively a grease spray with a long capillary tube can be used to apply the grease to the spring.

Important: Do not use oil spray! Oil spray solves the noise issue only for a while and removes the originally applied grease. The squeak noise will return after short time.

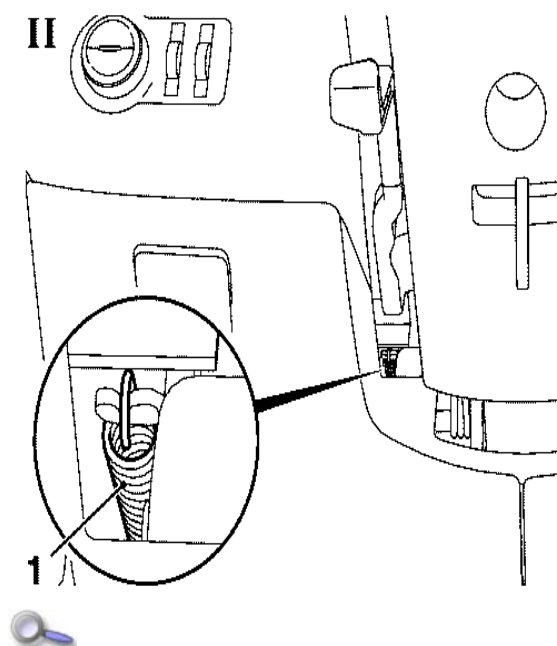
Access to the upper spring fixing point (important to be greased) of spring version I, is possible through the gap between the steering column trim and lower instrument panel trim. Lower part of the spring can be reached from the legroom.

Access to spring version II is also possible through the legroom.

1. Remove cover of fuse box instrument panel
2. Hang out fuse box and lay aside
(To achieve space for use of hand lamp)
3. Apply grease in idle and actuated position between the coils
4. Apply clutch several times to spread the grease

Note: Repeat operation until squeak noise disappears.

5. Hang in fuse box and install cover
