Technical Service Bulletin

2735

Subject: Radio CD400, CDC400 - USB Connector no Function

Brand:	Model:	Model Year:		VIN:		Engine:	Transmission:
		from	to	from	to		
Opel, Vauxhall	Astra-J	2010	2010			All	
Opel, Vauxhall	Insignia	2009	2010			All

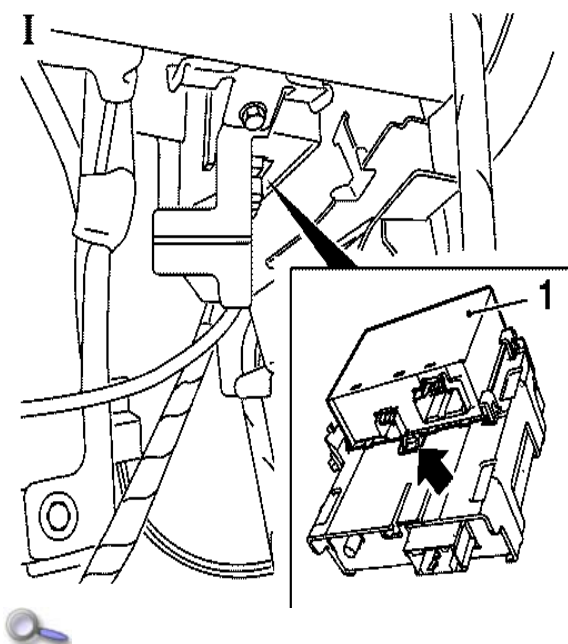
1. Disconnect battery
2. Remove instrument panel compartment
 - see working procedure "Instrument Panel Compartment Replacement", group "Body Hardware and Trim/Instrument Panel and Console Trim", Service Instruction Insignia. (Document Number 92141319)
3. Replace multi media interface module (Picture I, 1)
 - Disconnect 2 wiring harness electrical connectors
 - Detach multi media interface module (arrow) and pull out of bracket

In case of customer complaint replace the multi media interface module.
